project profile

Domestic Residence

Hillsborough

Replacement of a failed
earth retaining wall

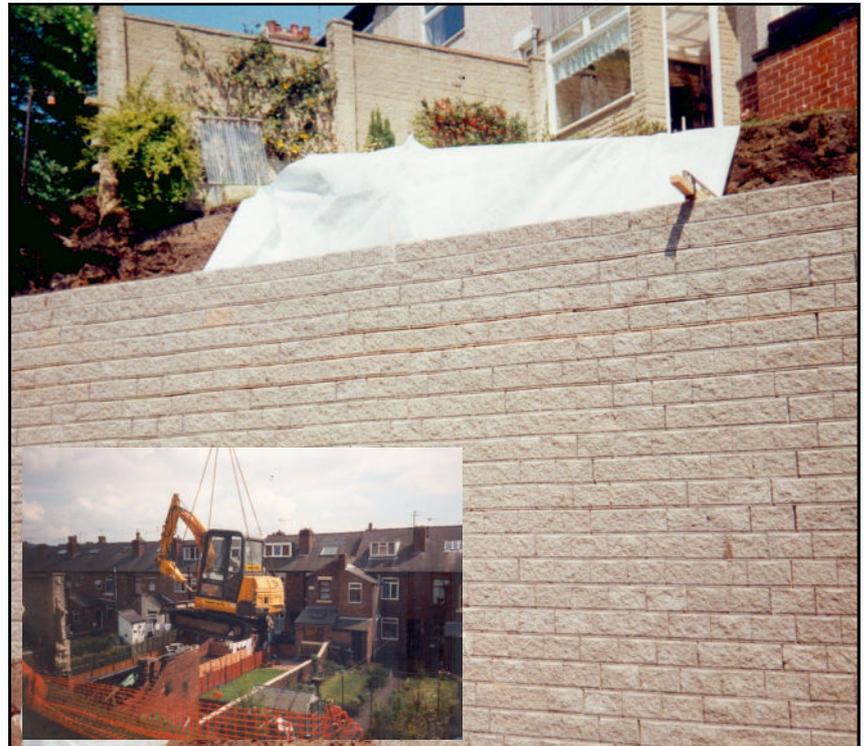
In this case, a failed 5 metre high retaining wall to the rear of a domestic property, posed a particular headache in considering a new replacement. With no access for plant or materials and a risk of further slippage, which would threaten the house itself, the options were limited.

After the construction of a concrete foundation the 500mm wide Leromur dry-build stone finish wall began to reinstate the earth slip, using Betonap geo-grids to form a composite mass wall structure, that filled into the slip profile.

The adopted solution was to introduce a 50 tonne mobile crane, able to reach over an adjacent single storey garage block and into the grounds of the property. Positioned within a road closure to the front of the property, the crane hoisted excavator plant and materials into place with in return excavated debris being lifted out in skips.
